Notification of Collection Centre Changes

12 July 2021

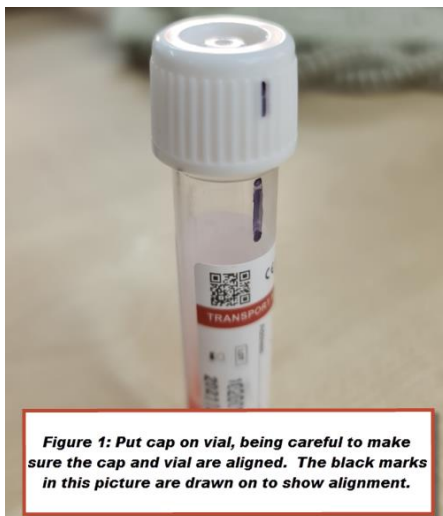
Figure 1: Put cap on vial, being careful to make sure the cap and vial are aligned. The black marks in this picture are drawn on to show alignment.

The number of leaking specimens reaching the laboratory has been slowly increasing again. The majority are the Citotest samples. The most common cause is that the caps are either not secured fully on the vial or put on without correct alignment with the vial. This prevents the seal being fully in place e.g. you can see or feel there is an angle between the bottom of this

1. There is a collar on the tube which prevents the cap from being over-tightened.
2. The amount to turn to completely seal the vial is 1 and ¼ turns (see photos attached)

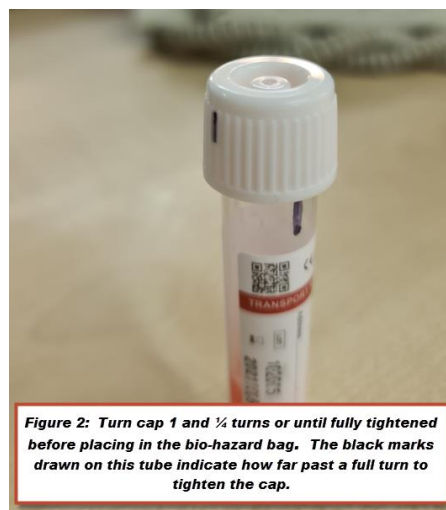
Figure 2: Turn cap 1 and ¼ turns or until fully tightened before placing in the bio-hazard bag. The black marks drawn on this tube indicate how far past a full turn to tighten the cap.
